The Ruins of the Gas Chambers: A Forensic Investigation of Crematoriums at Auschwitz 1 and Auschwitz-Birkenau

Daniel Keren, Jamie McCarthy, and Harry W. Mazal

Combining engineering, computer, and photographic techniques with historical sources, this research note discusses the gas chambers attached to crematoriums at Auschwitz 1 and the Auschwitz-Birkenau death camp. Among other things, the authors identify the locations of several of the holes in the roofs through which Zyklon B was introduced: five in Crematorium 1 and three of the four in the badly damaged Crematorium II. The authors began their project before David Irving's libel suit against Penguin Books and Deborah Lipstadt, proceeding simultaneously with, but independently of, the trial. The defense presented the first version of the authors' report during Irving's subsequent application to appeal. Irving's application was rejected by the court.

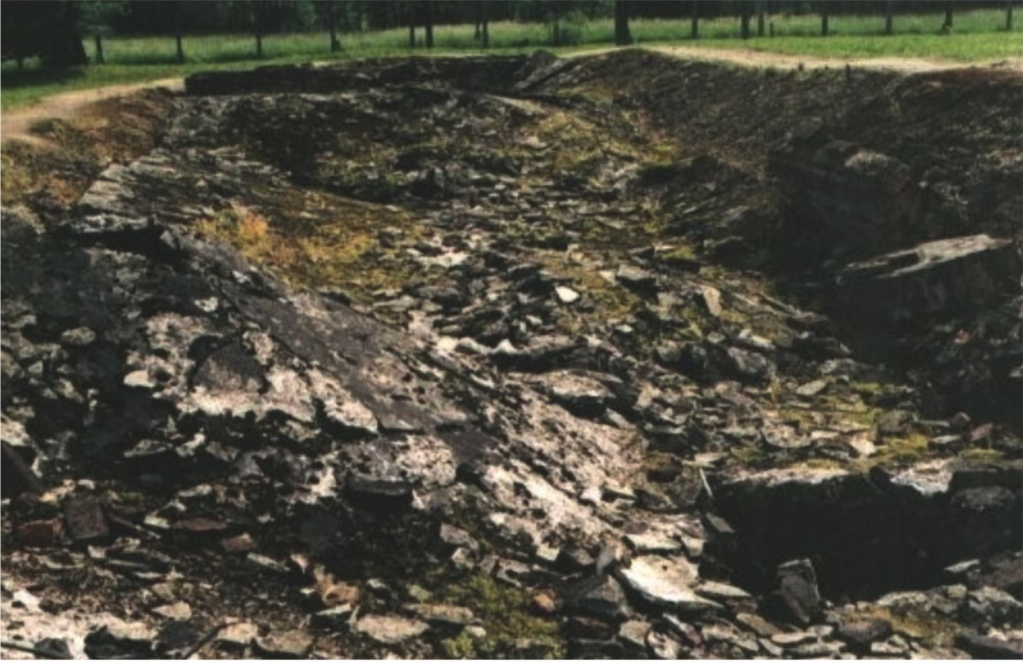
Figure 1b. Ruins of gas chamber in Crematorium II today.

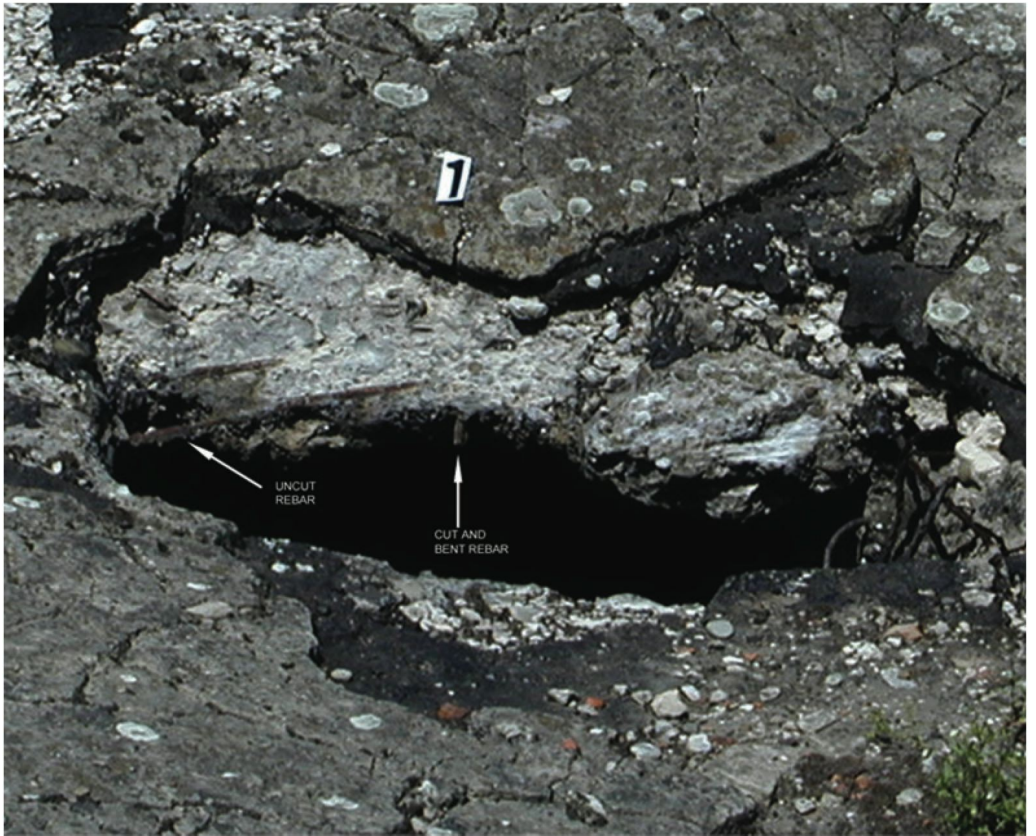
Figure 8b. Area of Zyklon Hole 1, Crematorium II. Tarpaper separating concrete layer below and sand-cement layer above is visible. South to north view.

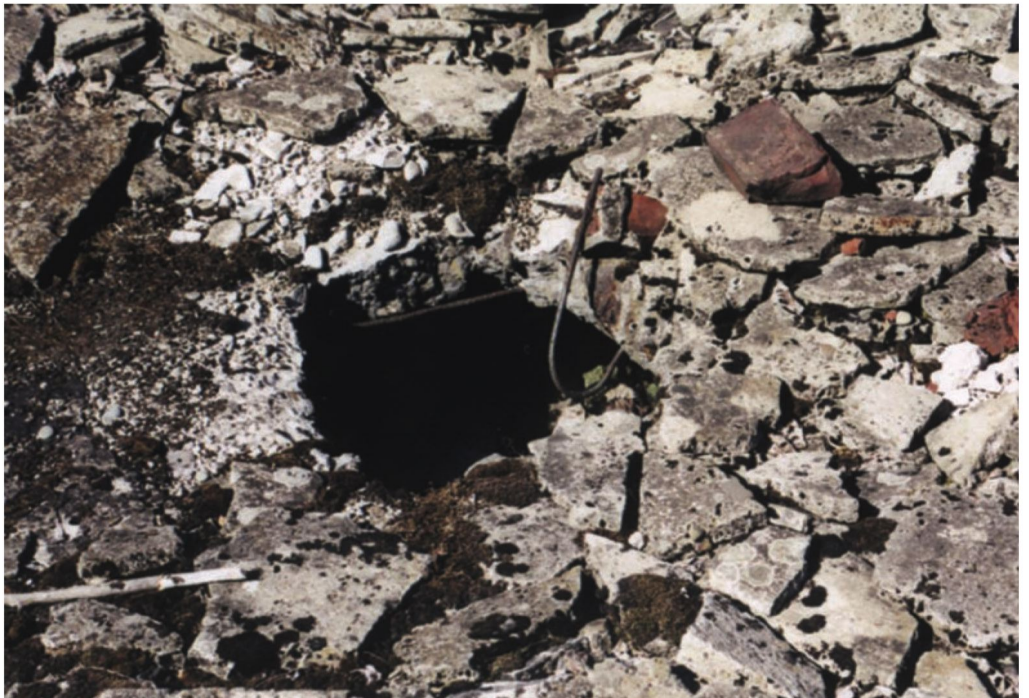
One current opening in the roof, near the approximate middle on the west side, does not correspond to any known Zyklon hole (Figure 9). Nothing marks this location on any known contemporary photograph, and a piece of rebar clearly ran across the hole before being cut and bent out of the way. This establishes that it was not a Zyklon hole. It is not known who made this hole, and we have no reason to believe that it was made before the liberation of the camp by the Red Army in January 1945. Clearly it was not made in an attempt to "fake" a Zyklon hole, or else the rebar would not have been left sticking out. This hole can be ignored for our purposes.

Figure 9. Hole cut for unknown purpose in Crematorium II roof, likely after liberation in January 1945.

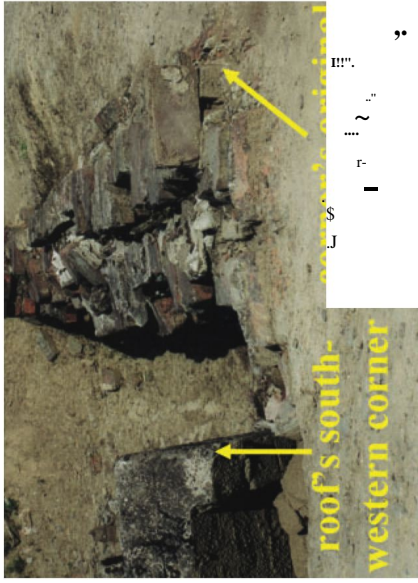
Figure 10a. West-east view of southern edge of Crematorium III gas chamber. Note how roof detached, shifted north, and tipped into hole (for comparison, brick length 23 cm). The shift left the first Zyklon hole farther north relative to first (southernmost) support pillar.

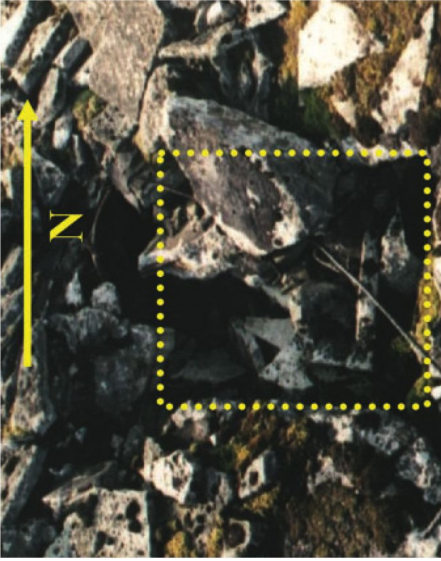
this was not the case. Portions of straight, flat edges and a 90-degree angle survive intact, though most of the concrete around the edge was damaged by the explosion. The center of this hole is 4.1 m from the southern end of the roof slab, and 0.75 m west of the roof's center. We estimate its size at approximately 0.5 m square; this places its eastern edge at 0.3 m west of the west edge of the central support beam.

Figure 12. Second (from south) Zykion hole, east to west view. Chunk of concrete torn away by explosion lies atop northern edge; western edge completely shattered. Outline of hole superimposed.

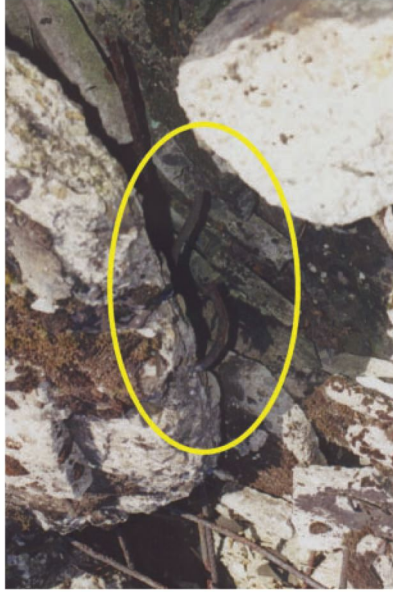
The form of the rebar, most importantly, cannot be explained as a consequence of the explosion that destroyed the roof. Such an explosion would

Figure 13. Straight edge and inward-bent rebar on southern side of second Zykion hole. Such bending could not result from the explosion, which lifted the roof upwards.

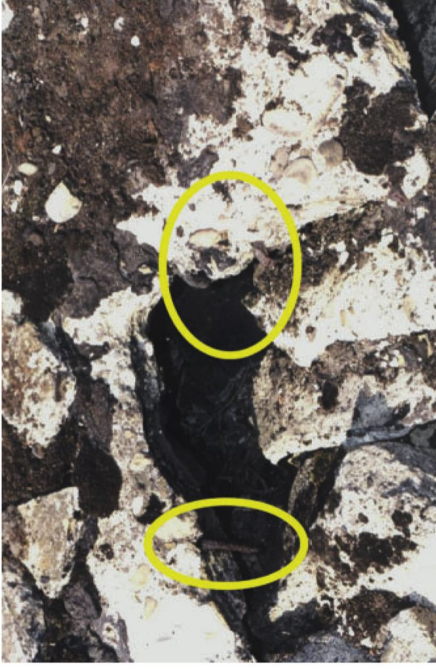
Figure 14. Inwardly bent rebar at north and east edges of second Zykion hole, partially destroyed in explosion.

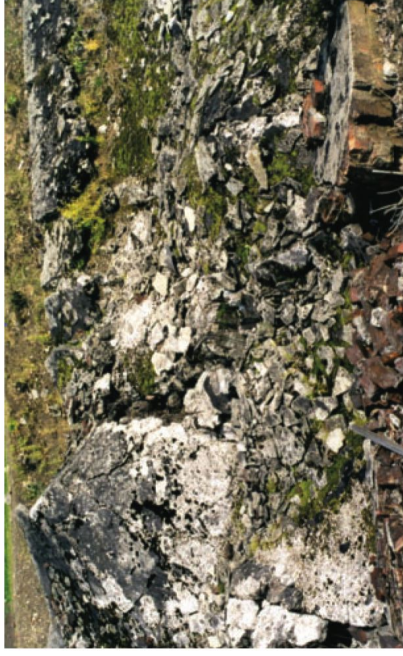
Hole 3's projected location is in an area of the roof that is badly damaged and covered with rubble (Figure 15). Preliminary research suggests that the hole itself may have been damaged when the roof collapsed on a portion of its own support structure. This hypothesis, however, requires further investigation. At the time this study was conducted, the researchers did not have permission to conduct the large-scale movement of rubble necessary to identify the third hole, but they are hopeful that permission may be forthcoming.

Figure 15. West-east view of hypothesized location of third Zykion hole.

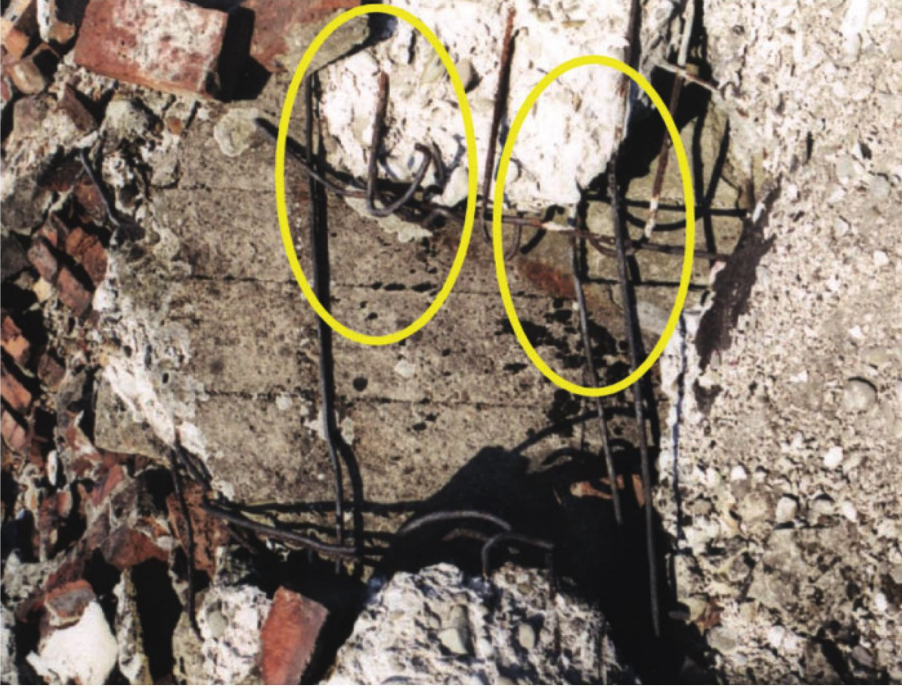
Figure 16. Remains of fourth (seen from south) Zyklon hole. Rebar skirts two sides, ends at other two sides bent inward and looped back. Note rotated roof slab showing formwork on inner side.

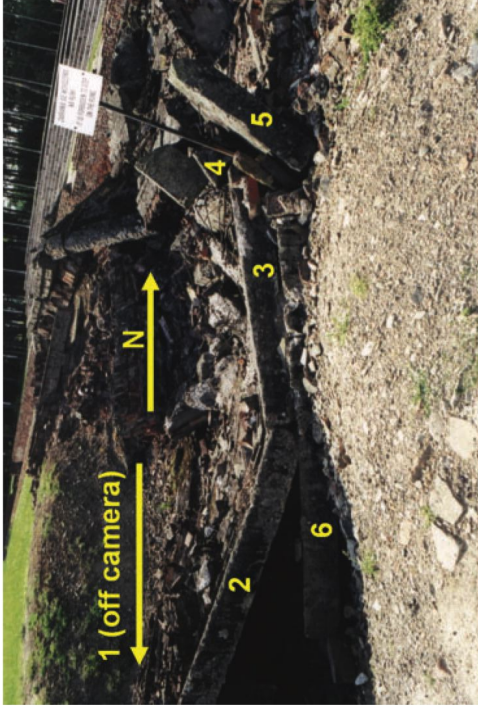
There is no question that part of the roof has folded underneath itself: that it is upside-down emerges from four observations. First, the rebar along the roof's north-south axis is still largely intact at the folds and can be observed running unbroken from the top portion of the roof, *ISO* degrees around, and through concrete into the bottom portion (i.e., between 3 and 6). Second, when the tar waterproofing was spread atop the concrete slab, it ran over the edge; the drips are visible to this day;

on the edge of this portion of the roof, the tar can still be seen, flowing, as it were, upward. Third, the upper part of "Section 6" (Figures 17 and 15) is the *inner* side of the roof, as seen in the imprint of the formwork. And fourth, the process of elimination: nothing resembling the missing northernmost roof slab (about 4 m in length) can be found anywhere else.

Figure 17. Close-up of fold area from eastern side. (Leaning sign on right is contemporary sign.)

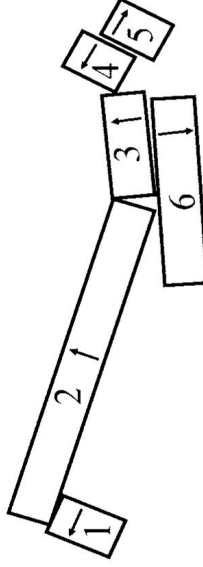
Figure 18a. How northern part of roof folded during explosion. Portion labeled 1 not in photograph. Fourth Zyklon hole 3 m west on portion 4. For exact scales see Figures 16 and 17. Eastern part of portion 4 shattered. Portions 5 and 6 were flipped over by the explosion (compare Figures 16, 17, and text).

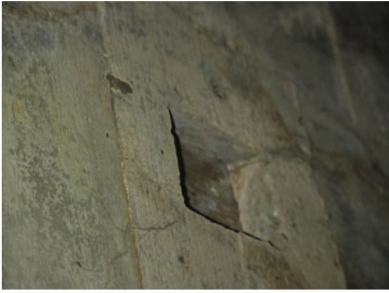
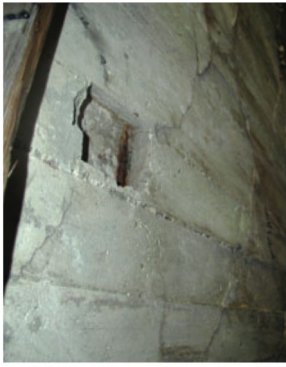
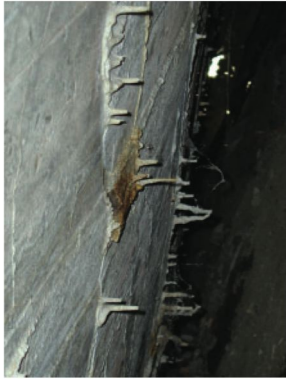
Figures 20a, b, and c. Three of the indentations in the gas chamber ceiling; in 20b (center), rusted rebar just touches inner edge; in 20c (bottom), wood block survives.

- i) A number of small (approximately 10 x 15 x 4 cm), rectangular cast indentations can be seen in the ceiling of the gas chamber. At least six of these are visible in those portions of the ceiling presently accessible from below. Some of the indentations have wooden blocks with visible rusted nails or screws. The indentations are uniformly placed and lined up on both sides of the support columns 2 m from the edge of the support beam, and extend from approximately 3 m north of the southern wall as far north as can be seen in the ruins. It is to the wooden blocks that fake showerheads reportedly were affixed (Figure 20).

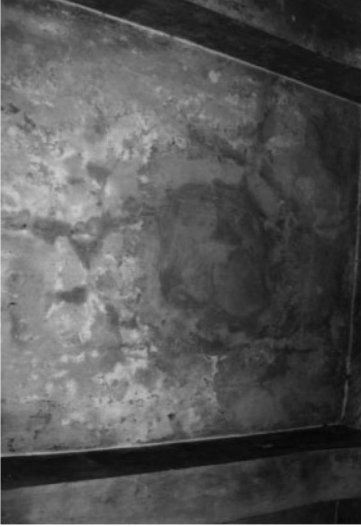
Figure 31. Sealed Zyklon hole Z1, which was not reopened during post-war restoration. Photograph taken inside chamber. It is not possible today to see the sealing signs on the roof, which was covered with heavy tarpaper.

It is easy to reconstruct the exact location of the Zyklon hole Z1 in the chamber's interior: it lies at the intersection of the straight line connecting Z2 and Z3, and the straight line perpendicular to the roof's longitudinal edge and passing through Z4 (see Figures 27 and 28). Exactly at this location there are clear signs of a square hole that was sealed (Figure 31). At two other locations holes were sealed, but these were circular ventilation openings (Figures 32a and b).²⁸

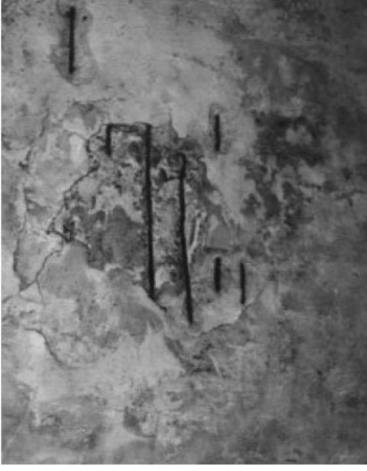
Figure 32b. Sealed ventilation openings in Crematorium I ceiling. It is not known why some rebar crosses opening.

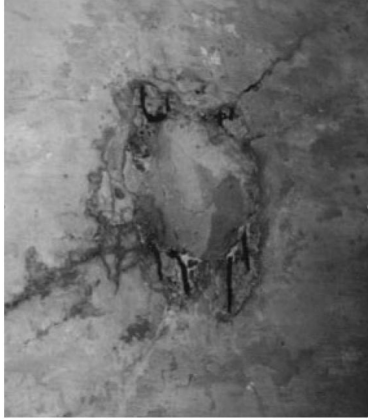
Figure 32a. Sealed ventilation openings in Crematorium I ceiling. These openings housed circular vents used to replace the air in the gas chambers.
