The Ruins of the Gas Chambers: A Forensic Investigation of Crematoriums at Auschwitz 1 and Auschwitz-Birkenau

Daniel Keren, Jamie McCarthy, and Harry W. Mazal

Combining engineering, computer, and photographic techniques with historical sources, this research note discusses the gas chambers attached to crematoriums at Auschwitz 1 and the Auschwitz-Birkenau death camp. Among other things, the authors identify the locations of several of the holes in the roofs through which Zyklon B was introduced: five in Crematorium 1 and three of the four in the badly damaged Crematorium II. The authors began their project before David Irving's libel suit against Penguin Books and Deborah Lipstadt, proceeding simultaneously with, but independently of, the trial. The defense presented the first version of the authors' report during Irving's subsequent application to appeal. Irving's application was rejected by the court.

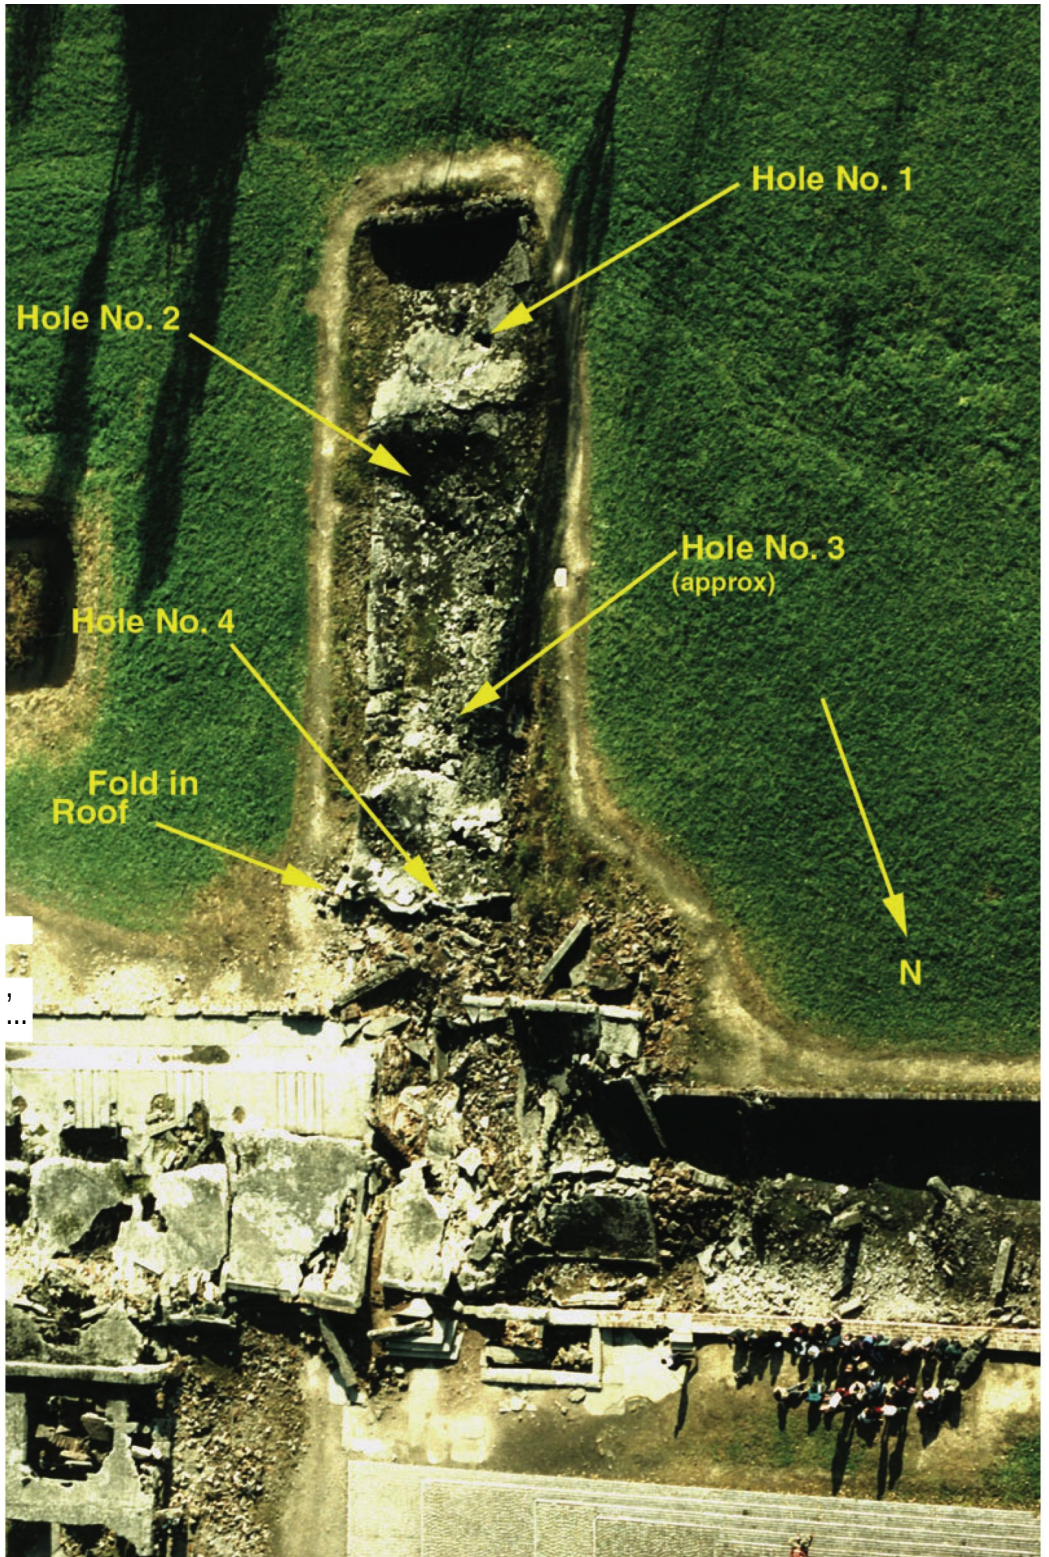
Figure 1a. Aerial photograph of the gas chamber in Crematorium II (courtesy of Wojciech Gorgolewski).

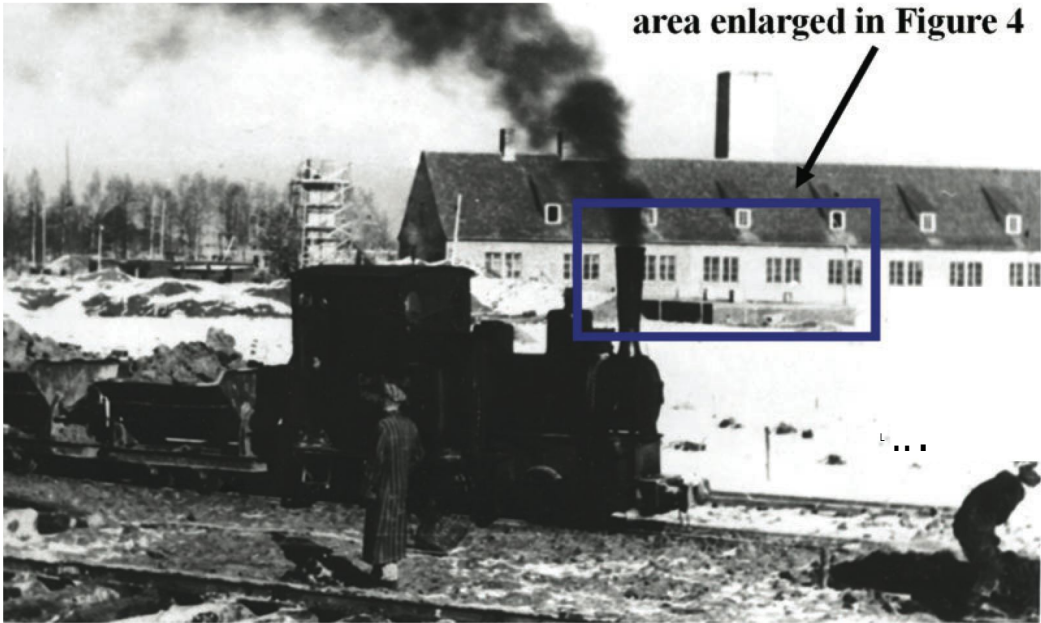
Figure 3. Photograph by team under SS-Unterscharführer Dietrich Kamann during construction of Crematorium II. Gas chamber visible in front, and three Zyklon "chimneys" can be identified. Hereafter the "Train Photograph." Courtesy of Auschwitz State Museum, PMO neg. no. 20995/494, Kamann Series; and Yad Vashem Archive.

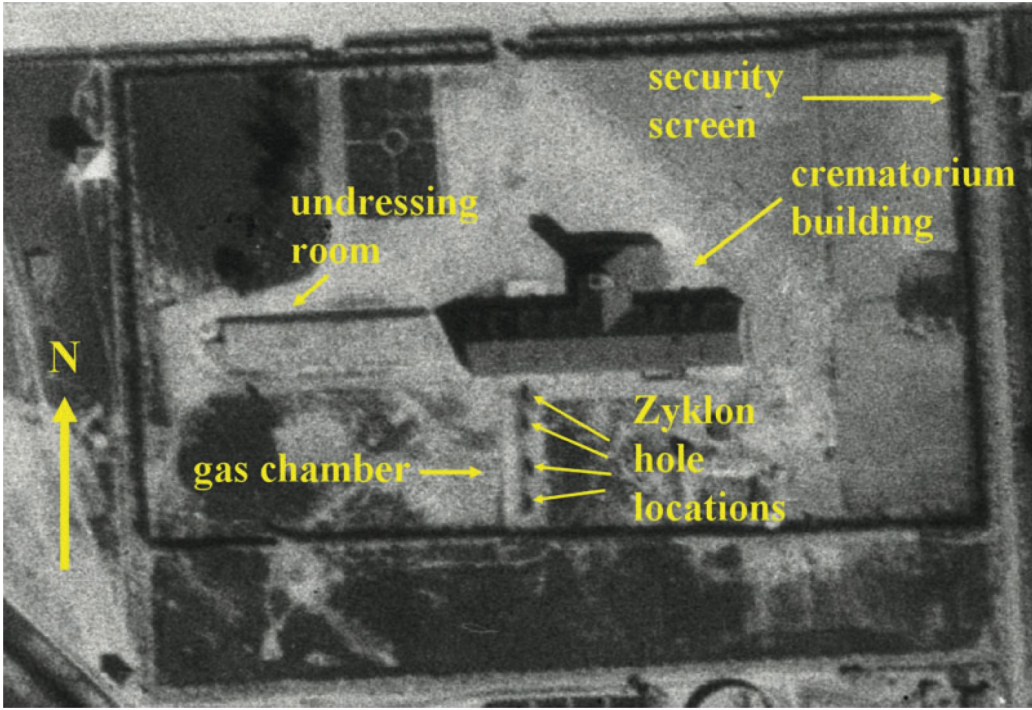
Figure 7. Detail of photograph of Crematorium II taken from American reconnaissance plane, August 25, 1944 ("August 25 Photo"). Heaped earth obscures east edge of gas chamber, making holes appear farther east. Holes alternate west-east-west-east (from south). National Archives and Records Administration (NARA), RG-373, Records of the Defense Intelligence Agency (DIA), Mission: 60PRI694 60 SQ; canoF5367, exposure 3186. Scale: 1/10,000; focallength: 12 inches; altitude: 30,000 feet.

- a) Water may have been poured on the extracted Zyklon pellets in order to dissolve the Zyklon and reduce the danger of accidental inhalation. Hosing down the pellets would also cause the wet areas of the earth cover to appear darker and could also have caused a different growth pattern of grass on the roof, resulting in a darker color; this is supported by the fact that areas with greenery appear darker in the photo (Figure 7).

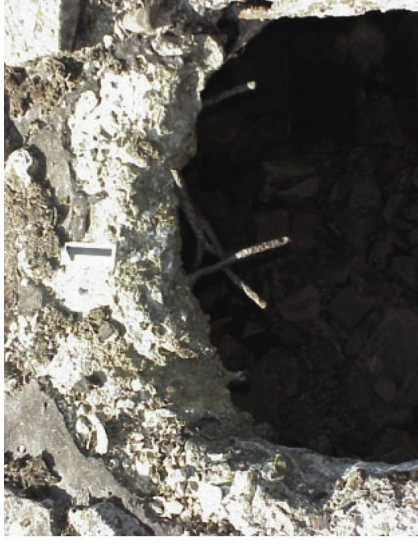
Figure 10c. Close-up view of southern edge of Crematorium III gas chamber, showing the brick wall and the hole. A white arrow points to the hole, and a black arrow points to the 'roof's south-western corner'. The text 'roof's south-western corner' is written in black at the bottom of the image.

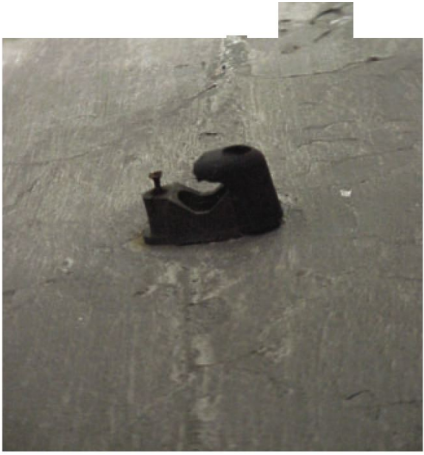
Figure 21. Bakelite supports found beside Crematorium II.

- The surviving wooden blocks all show signs of a screw or similar object inserted in their center as if to support something within the gas chamber.
- j) A large number of small wooden support blocks are attached to both sides of the central reinforced concrete beam. Several of these blocks still have attached to them small Bakelite plastic supports of the sort used to carry electric cable. The support blocks are visible all the way to the southern end of the support beam, some 2-3 m beyond the first showerhead block. Electric wires were most probably carried on these supports to provide current for illumination. Analogous supports in other parts of the concentration camp (e.g., Crematorium 1) bear electrical cables (Figure 21).

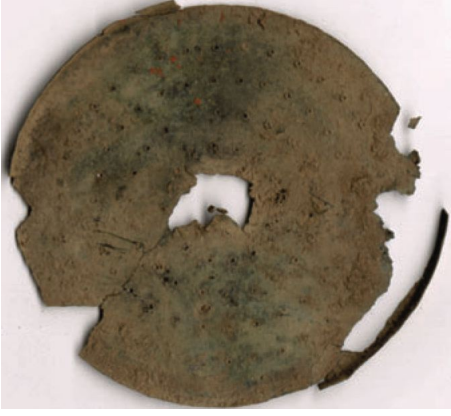
Figure 22. Rear of probable false showerhead found beside gas chamber of Crematorium II.

- k) We found a small disk 8 cm in diameter imbedded in the path less than one meter to the east of the gas chamber. The disk shows many small perforations (more readily seen on the reverse side) in a manner consistent with the front plate of a showerhead. The holes are of such a minuscule size-many

do not seem to perforate the plate at all—that it is unlikely that much, if any, water could have flowed through them (Figures 22 and 23). The sheet metal shows signs of having been galvanized, which would have inhibited rusting and made a "showerhead" more convincing. There is no evidence of any plumbing facilities in the gas chamber of Crematorium II. Given the convergence of evidence from eyewitnesses and documentation held in the archives of the Auschwitz Birkenau State Museum,¹⁸ this fixture undoubtedly formed part of the elaborate plan to keep the victims ignorant of their fate as long as possible.

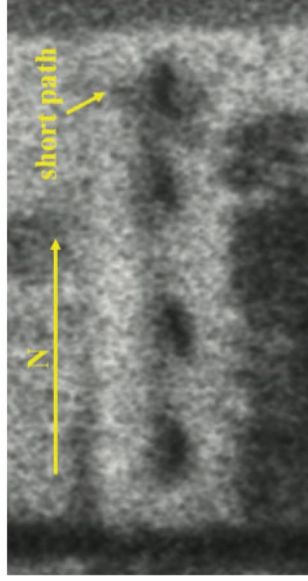
Figure 24. Enlarged detail of August 25 photo showing gas chamber rotated ninety degrees compared to Figure 7 so that edge of crematorium building is to right, security screen (likely a wattle fence) to left. Note darkened path along Zyklon hole locations, and short path extending west from the northernmost hole. Paths correspond to movement of SS personnel (see below).

It is impossible to observe the Zyklon holes themselves in any of the aerial photographs. To realize why, observe the gas chamber roof in Figure 24, which is the best suitable aerial photograph of Birkenau available. The gas chamber length is 30 m, while the holes' covers are about 60 x 60 cm. The low resolution and very strong granularity of the photograph don't allow direct observation of objects this size. However, certain phenomena associated with the holes can be identified. Also, given two overlapping photographs, both including the roof, the principle of stereo imaging may allow one to see more than is visible in a single image. We shall elaborate on this later. The best quality photo, and the one that has attracted most attention, was taken by an American plane on August 25, 1944; part of the photo is presented in Figures 7 and 24.19 A photograph of lesser quality, but still of interest, was taken from a German airplane on July 8, 1944 (Figure 25). The four dark, irregular smudges on the roof of the gas chamber in Figure 24 correspond to the location of the holes both in the Train Photograph (Figure 3) and to the physical findings (see the main part of this paper). However, it is clear that they are too large, and not in the correct shape, to represent the actual holes. In order to interpret the photo, we obtained the advice of Mr. Carroll Lucas, a leading expert with more than fifty years in aerial and satellite photo analysis.²⁰

- c) "The thin dark lineation (on positive prints) interconnecting the dark areas is a path of compacted earth produced by personnel moving from vent to vent." (See Figure 24.)

- d) "The dark area connecting this path to the edge of the roof from the vent nearest to the Crematorium roof is an extension of the path which shows where personnel gained access to the roof-possibly using a short ladder leaned against the roof." (See Figure 24.)

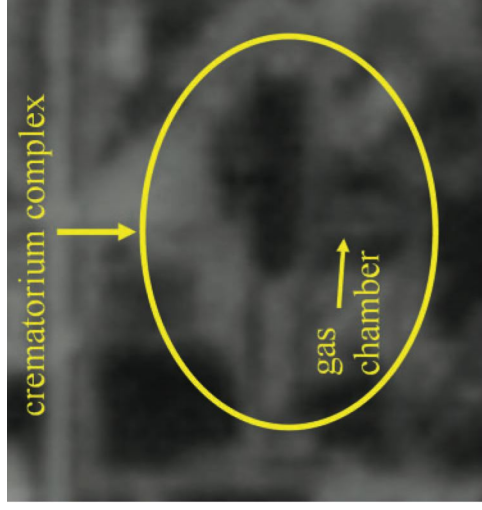
Figure 25. Detail of Luftwaffe photograph, Crematorium II area. The photo is of low quality but dark path along middle of the roof (compare Figures 7 and 24) slightly visible. NARA, RG-373, Auschwitz Box, envelope 17, security set GX D/TM-3/Germany-East Auschwitz/hcg. no. 38 N50 K19.

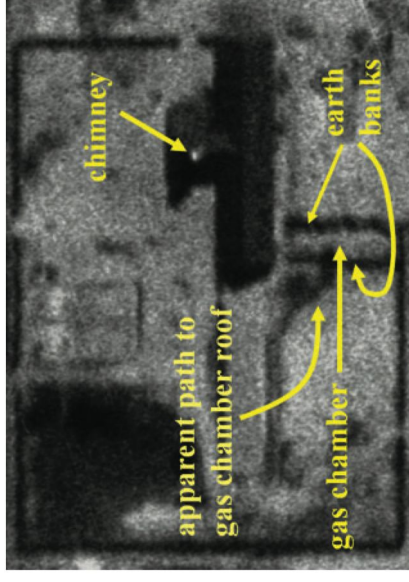
Figure 26. Detail of American aerial photograph taken on May 31, 1944, of Crematorium II area. Sunlight coming from east. Note camouflage earth banks against eastern and western edges of gas chamber, consistent with that appearing in left of Figure 4. Note also apparent path leading to gas chamber roof. In this photograph (as in Figure 4) roof is bare; dark line running along center in Figures 7, 24, and 25 consequently not visible: lines were likely the result of earth which was added later being compacted by personnel moving on roof (items 2 and 3 in Lucas' analysis). It is impossible to observe the holes' covers themselves (60 x 60 cm, the entire gas chamber being 30 m long). Resolution of this photograph lower than August 25 photograph. The camera actually looks down into chimney; the bright area, which does not appear in the August 25 photograph, may indicate cremation taking place. NARA, RG-373, DIA, Mission: 60 PRS/462 60 SQ; can: D1508, exposure 3056. Scale: 1/16,167; focal length: 20 inches; altitude: 27,000 feet.

Some earlier aerial photographs-for example, one dated May 31, 1944-show neither the smudges nor the dark line along the center of the chamber. One possible explanation is that the camouflage in the Crematorium area in general, and the gas chamber in particular, changed over time. In the Train Photograph for example, one can clearly observe an as yet incomplete earth bank with a triangular cross-section located on the chamber's western edge, while there is no earth cover on the roof. Such earth banks are visible in the May 31, 1944, photograph as well (Figure 26), but they do not appear in the July 8 and August 25, 1944, photos.

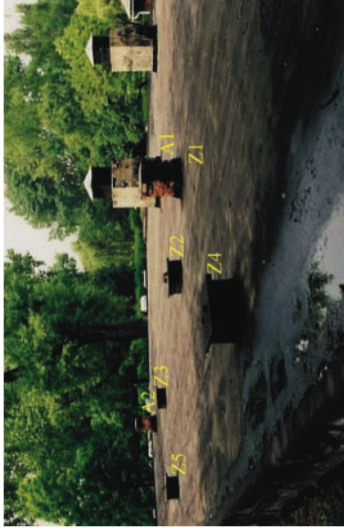
Figure 29. The roof today, with the same notations as Figures 27 and 28. Z1 was not reopened, but its location can be determined from Figure 28 and from measurement inside the chamber (see Figure 31 and relevant discussion).

The reader can see how the roof appears today in Figure 29. Figures 30a and b depict details from the current photograph (a) and the pre-restoration photograph (b) side by side.

It is easy to reconstruct the exact location of the Zyklon hole Z1 in the chamber's interior: it lies at the intersection of the straight line connecting Z2 and Z3, and the straight line perpendicular to the roof's longitudinal edge and passing through Z4 (see Figures 27 and 28). Exactly at this location there are clear signs of a square hole that was sealed (Figure 31). At two other locations holes were sealed, but these were circular ventilation openings (Figures 32a and b).²⁸

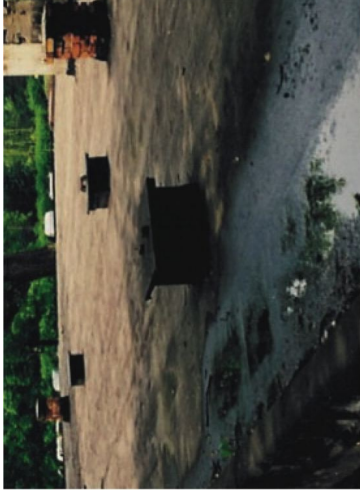
Figure 30a. Detail of current photo. Z5 lies outside the image (only the very corner of the wooden cover and its shadow are visible).

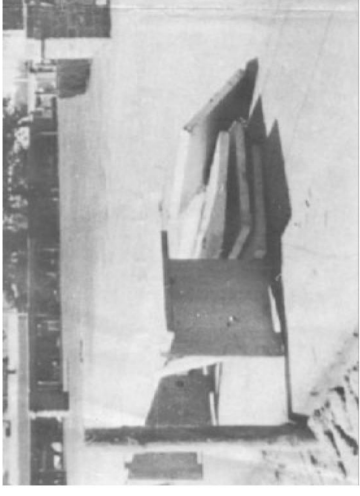
Figure 30b. Detail of pre-restoration photo, scaled and aligned. Images do not correspond exactly because they were not taken from exactly the same point (see Figure 33 and relevant discussion). The roof appears higher today (30a) due to added waterproof coating.

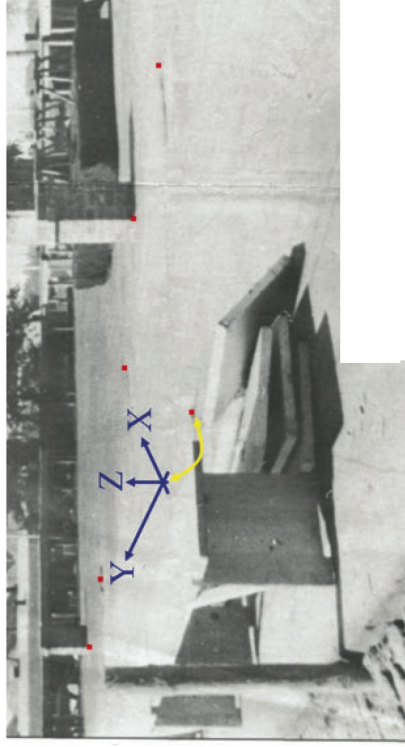
Figure 33. Rendering of measured points (hole corners) against pre-restoration photo, matched via mathematical camera model. Computation based on coordinate system sketched in blue and positioned at Z4 corner. Rendered points, marked by red squares, correspond to locations of air vents and Zyklon holes taken in roof's current condition. Match between photo and rendering proves Zyklon holes were indeed reopened at original locations. Z5 located outside photograph, consistent with its rendering (red square to left of photo).

squares, and they correspond very well with the photograph. The location of Z5 corresponds to the red square outside the photo (to the left) and indeed it is not visible in the photo (see also Figure 33). The photographer's location was determined to be at the following location, compared to the corner landmark of Z4, with a Cartesian coordinate system aligned with the roof, with its *x-axis* along the roof's horizontal (width) axis, *y-axis* along the longitudinal side of the roof, and the *z-axis* pointing upwards. Relative to this coordinate system, the recovered location of the photographer was at (-2.675, -5.575, 0.75 m), and the roof angles with respect to the camera's plane were 0.725 at the *x-y* direction, and 0.175 at the *y-z* direction (angles in radians). This means that the photographer was standing to the left and slightly to the front of the roof corner (see Figure 27), on the sloping earth embankment, which accounts for the low value of the *z* coordinate (possibly the photographer was also kneeling, or the camera was mounted on a tripod).
