# Some Technical and Chemical Considerations about the ‘Gas Chambers’ of Auschwitz and Birkenau

GERMAR RUDOLF

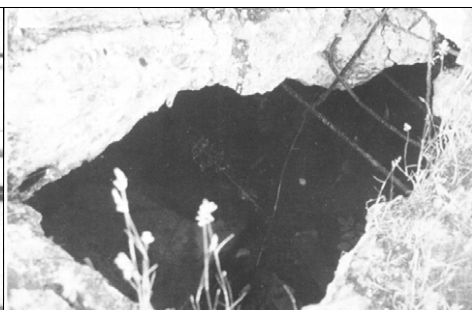
**Illustration 6:** Alleged Zyklon B input hatch in the roof of mortuary 1 (‘gas chamber’) of crematorium II; entrance to part of the cellar still accessible today.

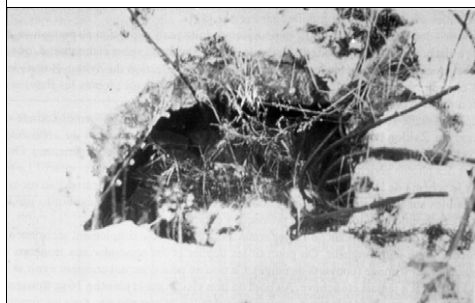
**Illustration 7:** Alleged Zyklon B input hatch in the ceiling of mortuary 1 (‘gas chamber’) of crematorium II. It is clearly visible that the reinforcing bars in the reinforced concrete were not even removed; they were merely bent back.

What is more, at the opening shown in *illustration 7* the reinforcement bars were only cut through once and then bent back. They are still full length. It would be quite possible to bend them back down and weld them to the protruding stubs at left (covered in snow), although we advise no one to try it in order to avoid any damage to these extremely important pieces of evidence.<sup>60</sup> Remnants of the reinforcement bars are also still visible at the edge of the hole in *illustration 6*. No devices for the introduction of gas could ever have been securely installed, much less sealed to the outside, in such crudely cut and unfinished holes from which not even the reinforcement bars had been removed. Any attempt to do so would have endangered the entire vicinity, including the alleged perpetrators, with the poison gas that would have escaped in enormous quantities. What is more, only brute force could have stopped the supposed victims from escaping through these holes or even throwing the poison gas carrier out, since after all these holes could never have served as input hatches – they were never finished.

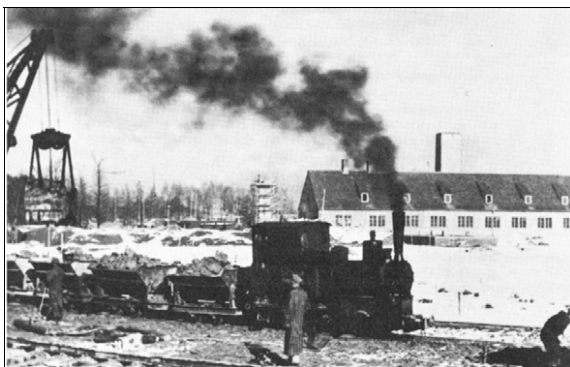
**Illustration 9:** Photography of crematorium II in Birkenau, February 1943.
